Scaffold Board Failure

Published by the NASC (National Access & Scaffolding Confederation) 12/02/2010

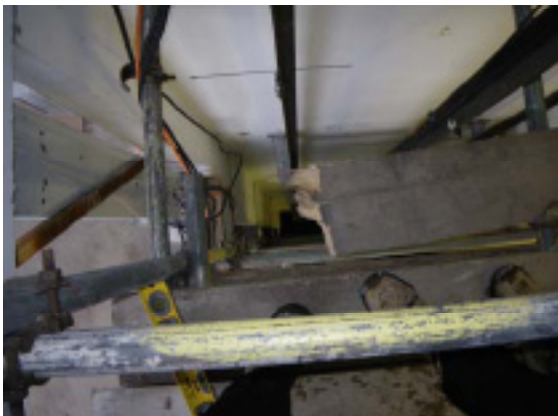
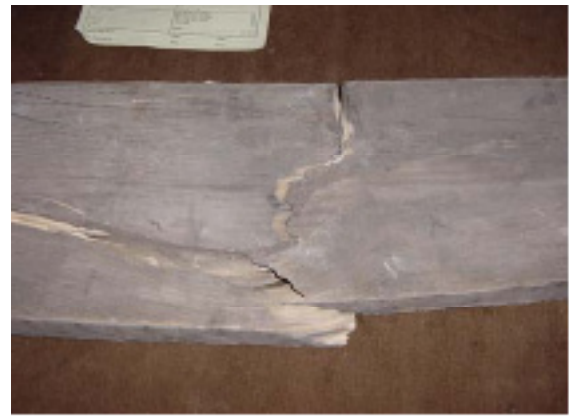
1

As a part of the investigation, the scaffold board was inspected by an expert who concluded that the cause of the failure was that the timber contained a very pronounced slope of grain in the region of the break.

In this instance the board that failed would be commonly known as a 'Grade A' board because it did not have the British Standard marking on the end plates.

This grade of board is not subject to the requirements of BS2482 and therefore would never have been inspected for any potential strength defects.

- Check if your scaffold boards conform to BS 2482
- Consider changing any non British Standard boards to boards graded to the current BS2482 standard.
- In the future consider only providing scaffold boards graded to BS2482 in any contract for scaffold supply / erection of scaffolding.
- Boards should not be used as a part of a working platform if they are damaged in any way, cracked or have notches cut out of them.
- Boards should be inspected prior to being put into use and at regular intervals whilst in use
